Fiscal Year 2013 Revegetation Assessment

November 2013

INL/EXT-13-30713

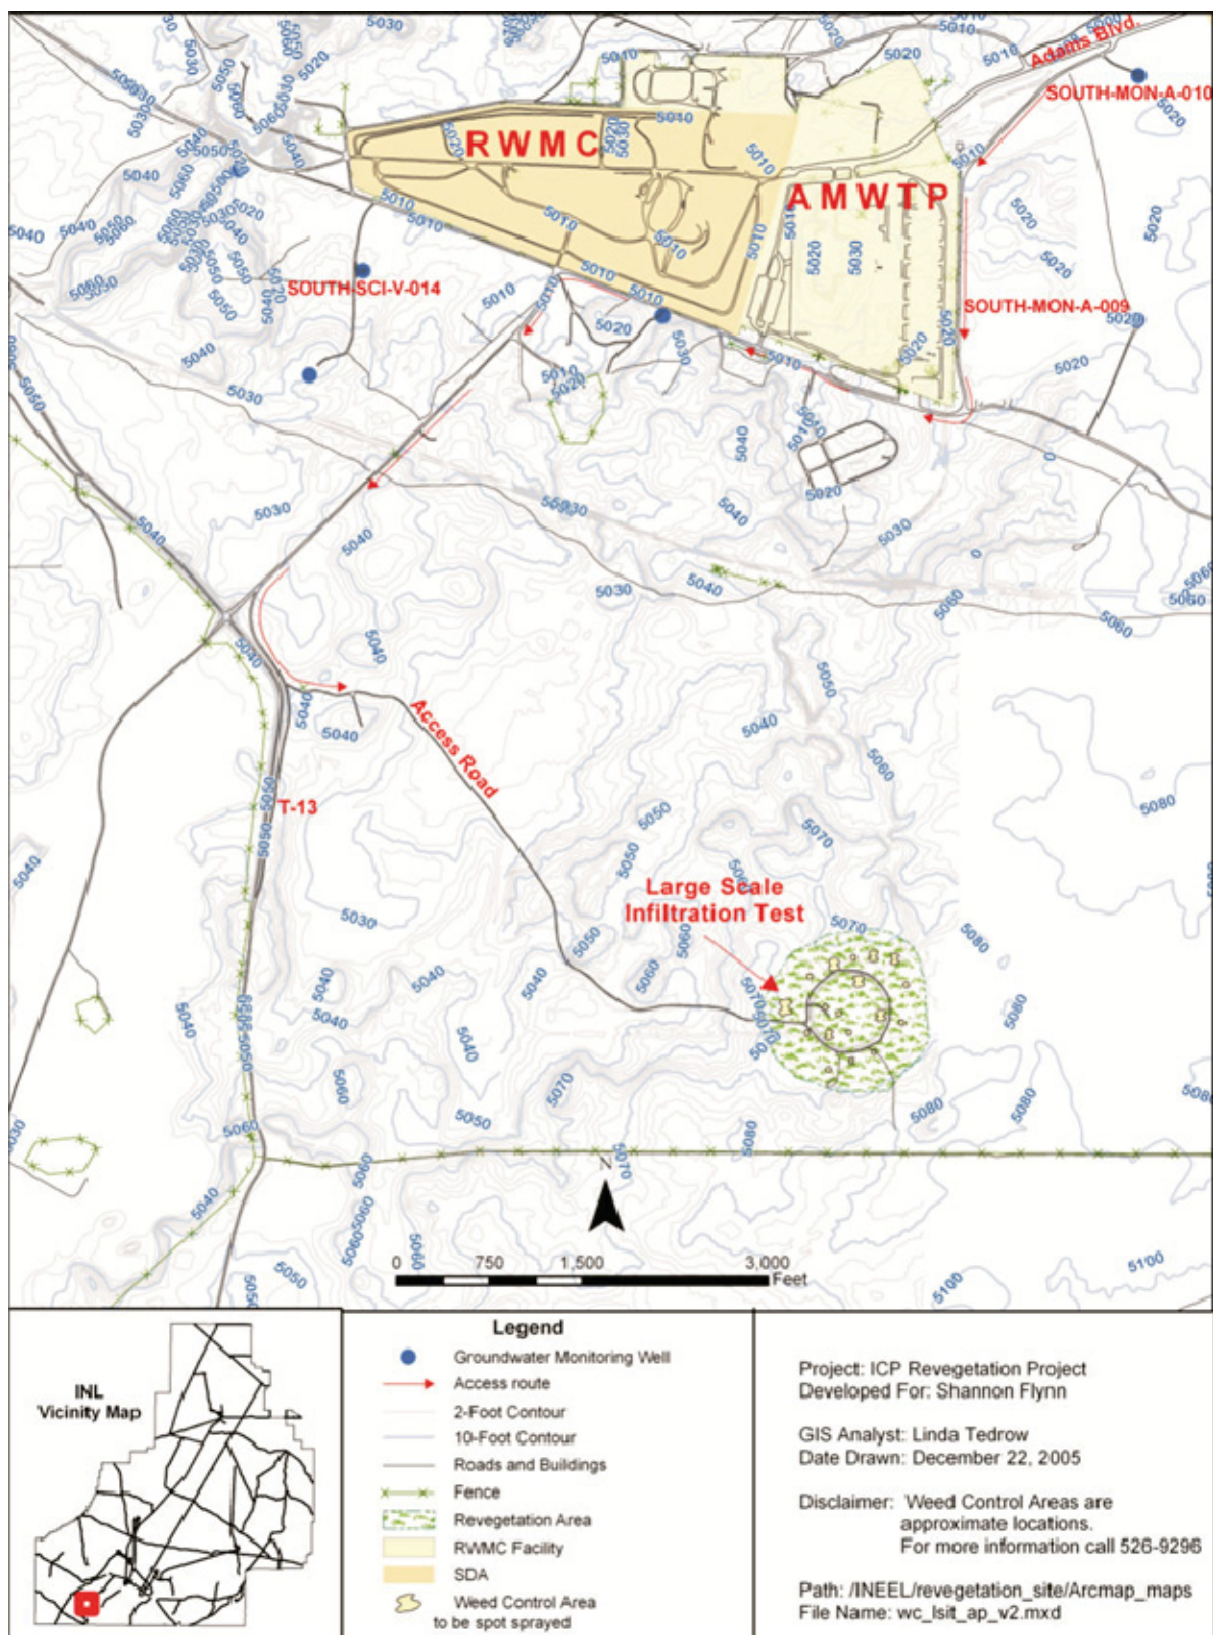
Figure 1. Map of the Large Scale Infiltration Basin.

The Large Scale Infiltration Basin is a Long Term Stewardship site located about 0.9 miles south of the RWMC (Figure 1). The *Weed Control and Revegetation Report for Fiscal Year 2006* (ICP January 2007) recommended that the site be monitored until the disturbed area meets 70% cover of background. The site is now part of the Radiological Response Training Range (RRTR). Vehicle traffic is allowed on the disturbed area as part of training exercises, and vehicle tracks were observed within the basin.

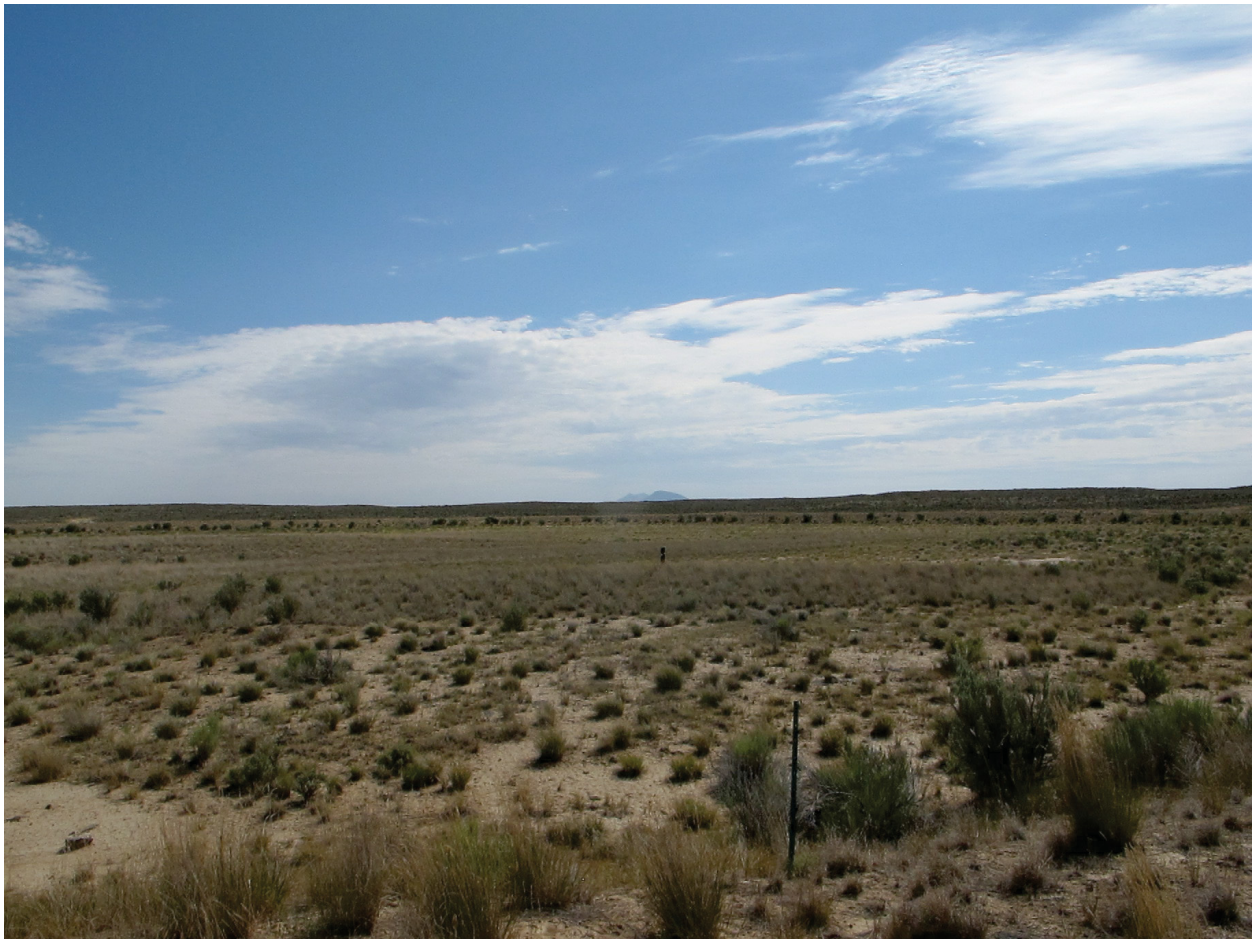
Figure 2. Revegetation at the Large Scale Infiltration Basin

Vegetation appears to be uniformly distributed throughout the disturbed area. However, a few small bare areas do exist. Mean perennial cover of the disturbed area at the Large Scale Infiltration Basin site was 62.1% in 2012.

Native species appear to be establishing well at the Large Scale Infiltration Basin. Squirreltail, sagebrush, and grey and green rabbitbrush are established around the rim. Crested wheatgrass and cheatgrass as well as native wheatgrasses and Indian ricegrass were also observed. Sagebrush, crested wheatgrass, mixed wheatgrasses, bottlebrush squirreltail, foxtail barley (*Hordeum jubatum*), and both grey and green rabbitbrush with some cheatgrass have established within the interior of the basin. Annual and nonnative species within the disturbed area include halogeton (*Halogeton glomeratus*), desert alyssum (*Alyssum desertorum*), and cheatgrass. Soil erosion was not observed at this location.

Figure 2 shows an overview of vegetation establishment in the area.

The disturbed area at the Large Scale Infiltration Basin is close to meeting 70% percent cover of background vegetation. Reaching the final stabilization criteria at the site may be hampered by vehicle traffic associated with RRTR activities. It is recommended that the site continue to be visually evaluated in the yearly revegetation assessment to determine if activities associated with the RRTR are impacting revegetation efforts, and that digital camera sampling be conducted if it appears that RRTR activities are not impeding growth of vegetation and when the area appears to reach the 70% criteria for final stabilization.

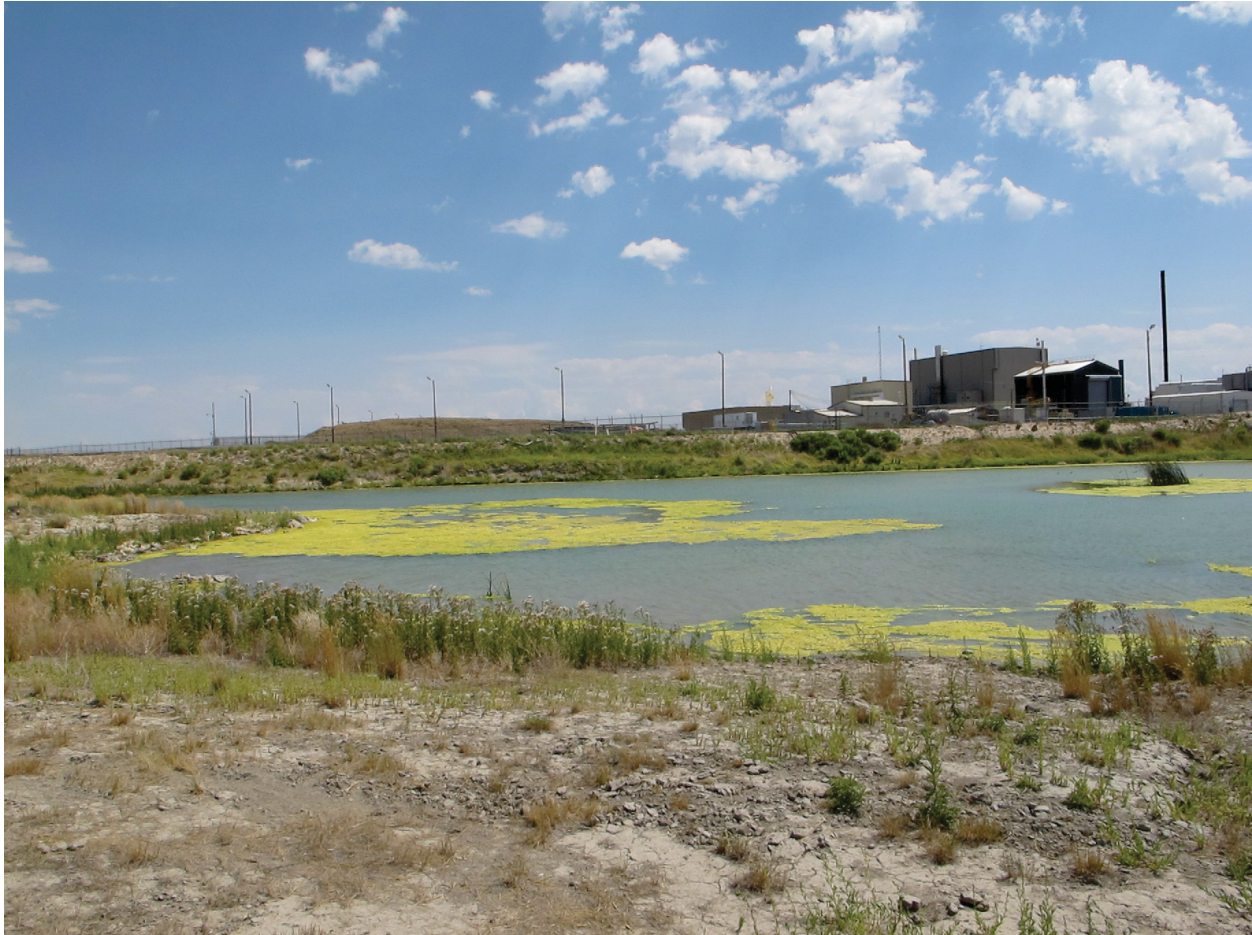
Figure 3. Revegetation at the MFC IWP.

Conditions have changed little since 2012. The southern end of the MFC IWP has a good perennial vegetative cover. Species present include Wyoming big sagebrush, green rabbitbrush, crested wheat grass, and globemallow. Several young sagebrush plants were observed. This small area may be close to reaching the 70% criteria.

Figure 3 shows the MFC IWP. Canada thistle is present in the area surrounding the MFC IWP and ranges from sparse to thick depending on the location. Cheatgrass is present towards the southern end and becomes very thick at the northern end of the MFC IWP. Crested wheatgrass appears to be increasing

throughout the area based on the number of young plants observed. This is expected since crested wheatgrass is prevalent in the area surrounding the MFC complex. Kochia was present in bare areas. As in previous years, Russian knapweed (*Rhaponticum repens*) is present along the eastern side of the IWP. The site was sprayed in July.

Crested wheatgrass and Wyoming big sagebrush appear to be increasing in certain areas of the revegetation site. A visual evaluation was performed in 2013, and site conditions are similar to what was encountered in 2012.

Because recovery of the site is slow, it is recommended that the site be monitored every 3 to 5 until the entire site appears to reach final stabilization, at which time the digital camera sampling method will be used to confirm the site has reached 70% of background cover.

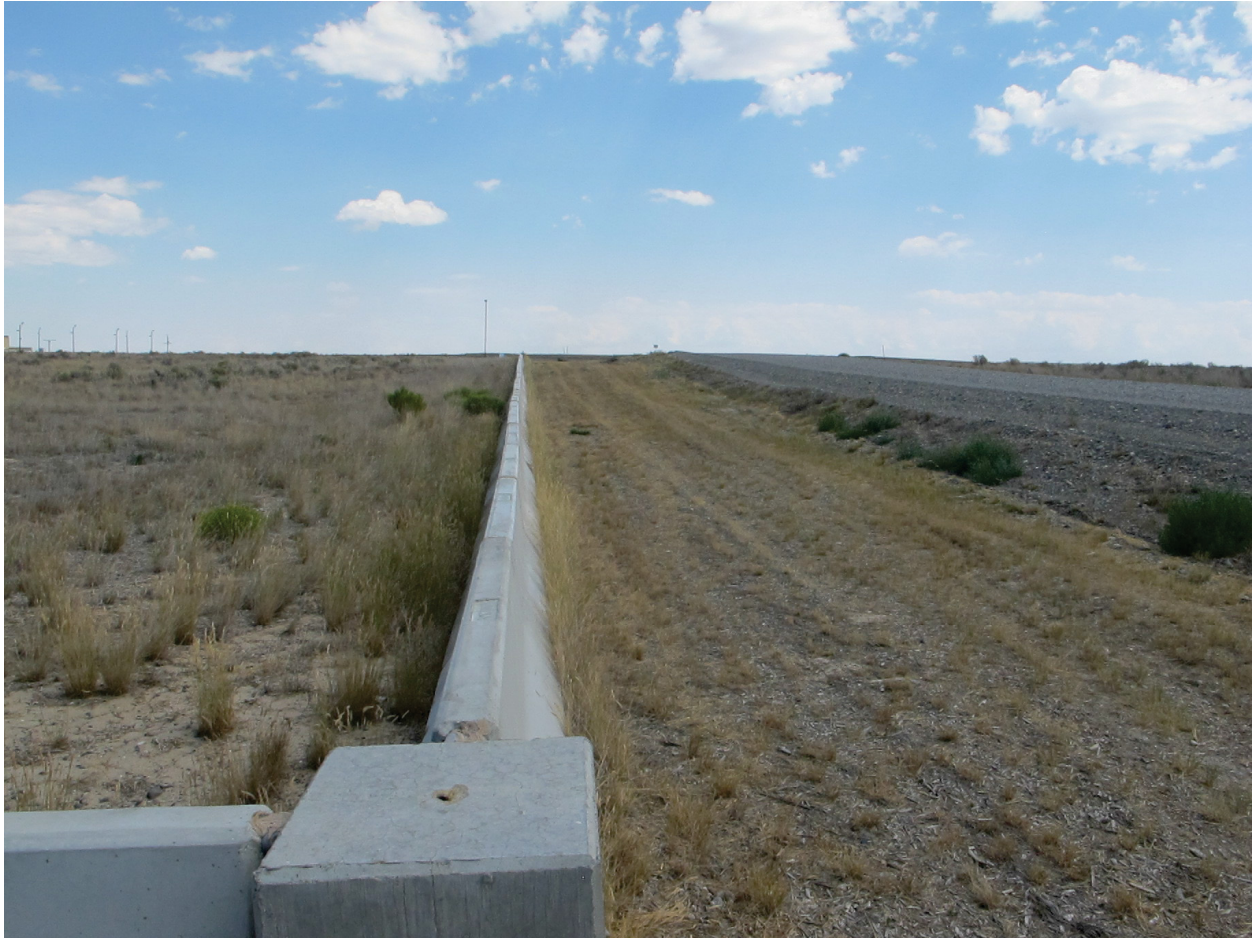
The perimeter of the MFC Vehicle Barrier Project is mowed as part of the seasonal wildland fire protection barrier. The area mowed extends nearly the entire perimeter, except for a small section on the northeast corner of MFC, north of the NOAA tower (see Figures 4, 5, and 6).

Figure 4. Mowed fire protection barrier on the south side of the MFC Vehicle Barrier Project.

Because the area surrounding the project is dominated by crested wheatgrass, it is expected that crested wheatgrass will eventually become the dominant species on the disturbed sites. Mowing of areas will likely continue as part of INL fuel management in accordance with the environmental assessment for Wildland Fire Management (DOE/EA-1732). For these areas, vegetation should be considered complete until mowing no longer occurs.

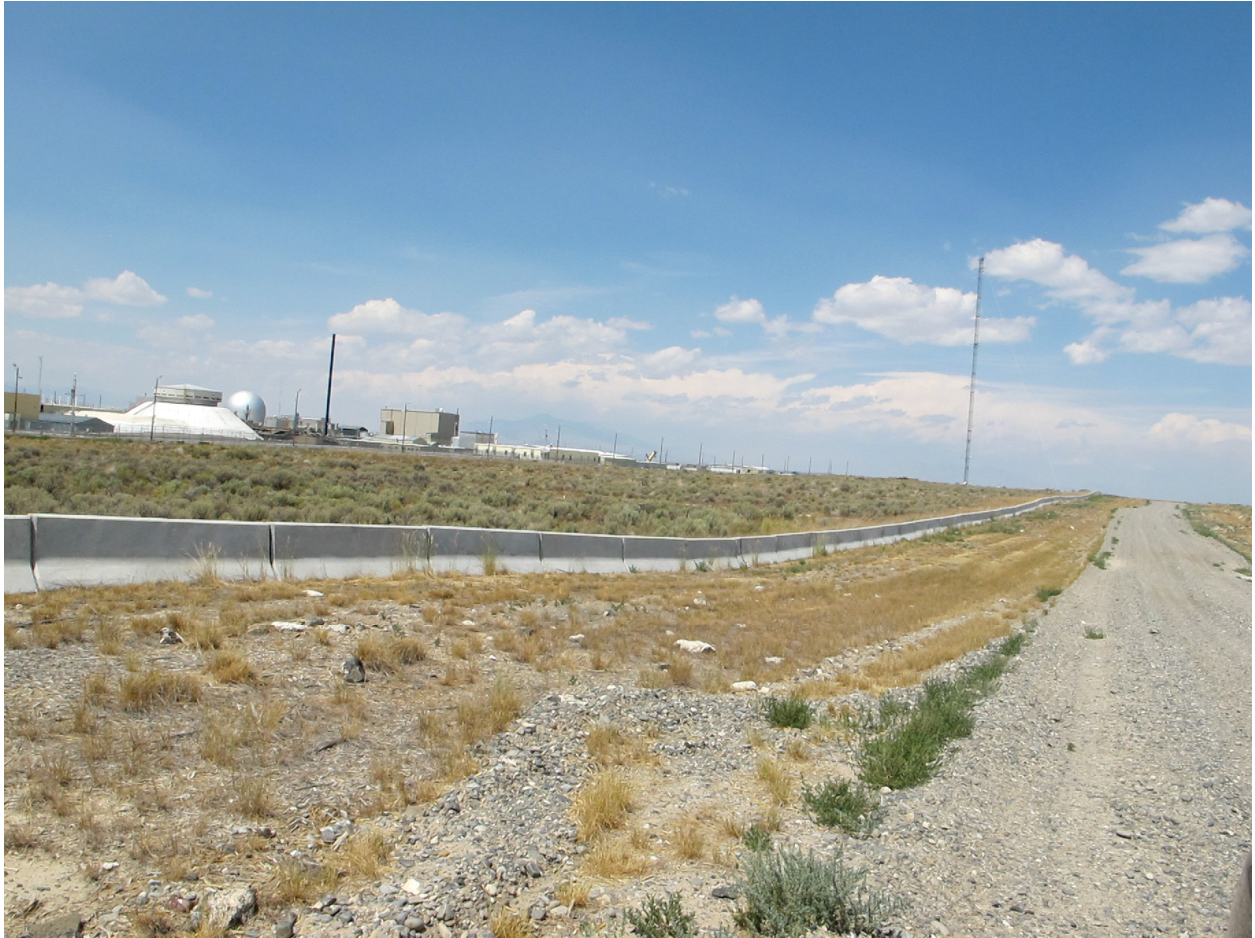
Figure 5. Mowed fire protection barrier on the east side of the MFC Vehicle Barrier Project.

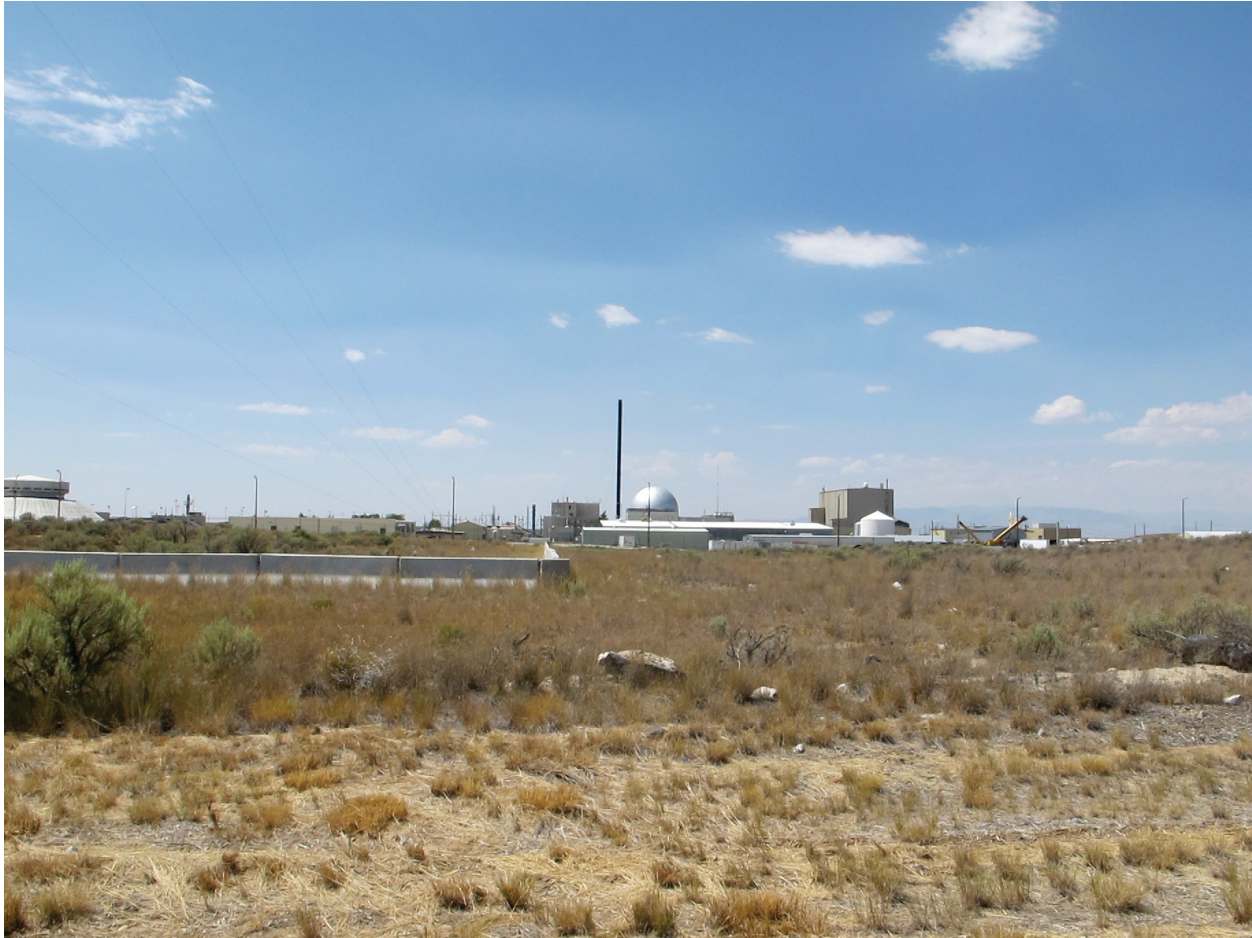
Unmowed areas exhibit less sagebrush and other shrubs compared to background areas, but crested wheatgrass and the other native species that have established appear to be stabilizing the soil.

Figure 6. Unmowed area along the northeast corner of the MFC Vehicle Barrier Project.

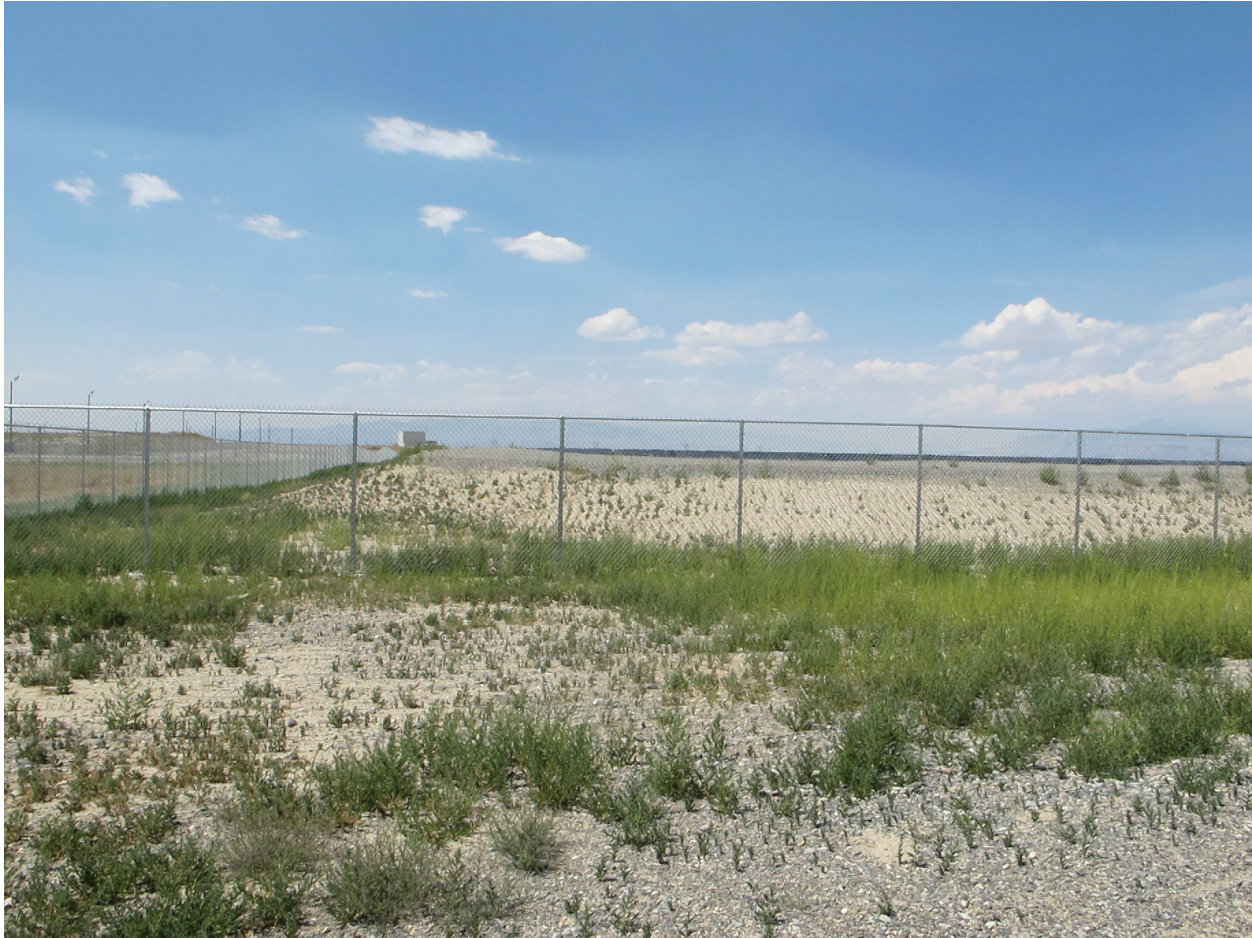
Figure 7. Revegetation at the MFC New Sewage Lagoons

The MFC New Sewage Lagoons Site was visually observed in 2013. Figure 7 is representative of the current condition of revegetation at the location.

Kochia was the predominant species occupying the site with a few patches of cheatgrass also observed. Supplemental water was not provided to the reseeded area, and it does not appear that seed sprouting from the revegetation effort occurred. Bare ground in the disturbed area is extensive.

Additionally, as shown in Figure 7, seeding occurred in rows running perpendicular to the top surface of the sewage ponds, increasing the likelihood for soil erosion.

The New Sewage Lagoon Site should be revegetated. It is recommended that the top soil be raked or ripped to create an adequate seed bed and that seeding occur in rows parallel to the top surface of the berm to minimize erosion on the slop of the lagoons. Supplemental water may need to be provided for several growing seasons to ensure successful revegetation. The area should continue to be monitored annually until revegetation establishment approaches the 70% criteria, at which time digital camera sampling will be performed to verify final stabilization.

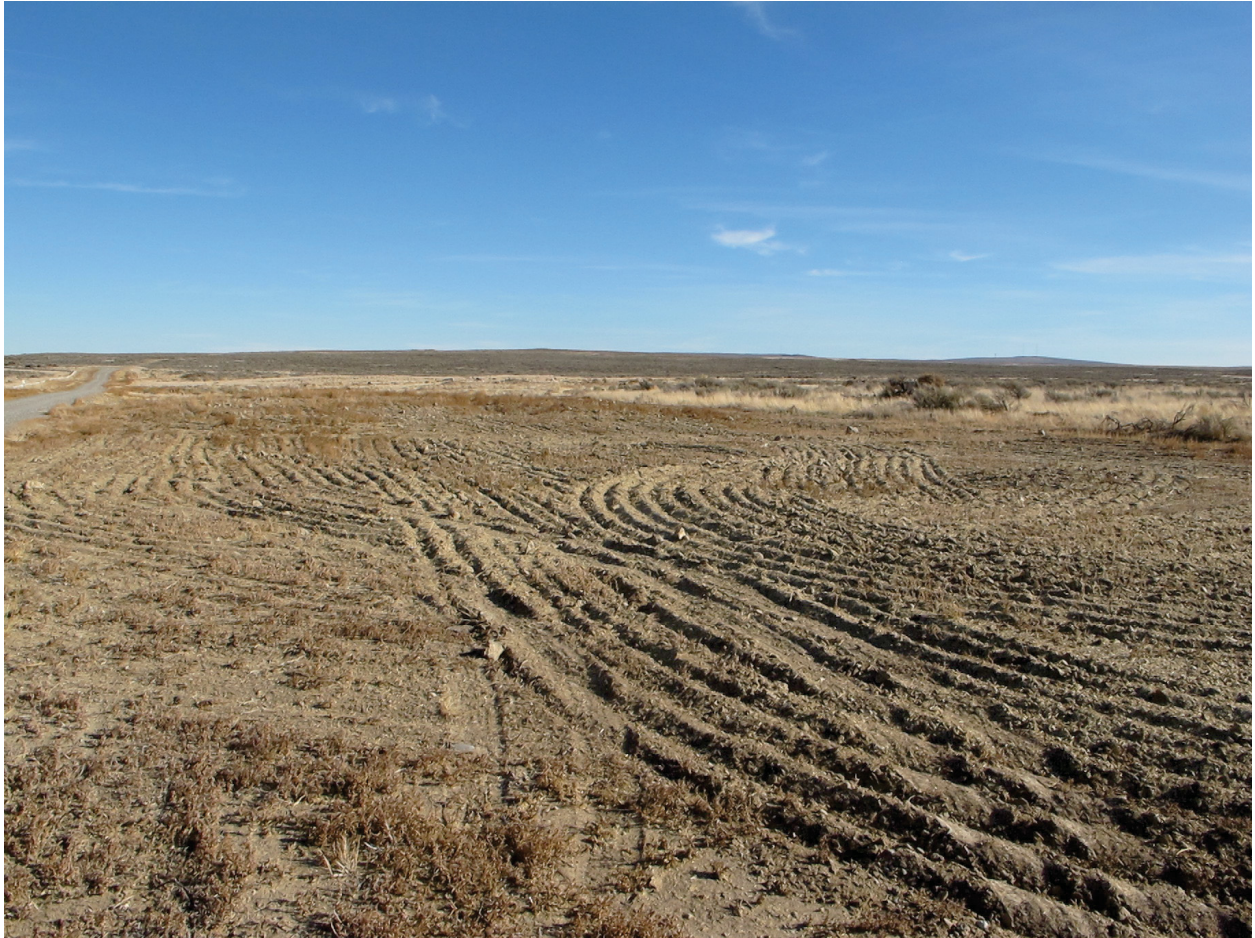
Figure 8. MFC Soil Pile Location

The MFC Soil Pile location was visually observed. Figure 8 shows the MFC Soil Pile location.

The Soil Pile Location should be revegetated. It is recommended that the top soil be raked or ripped to create an adequate seed bed and that the area be seeded with an approved native seed mix. Supplemental water may need to be provided for several growing seasons to ensure successful revegetation. The area should continue to be monitored until revegetation establishment approaches 70%, at which time digital camera sampling will be performed to verify final stabilization.

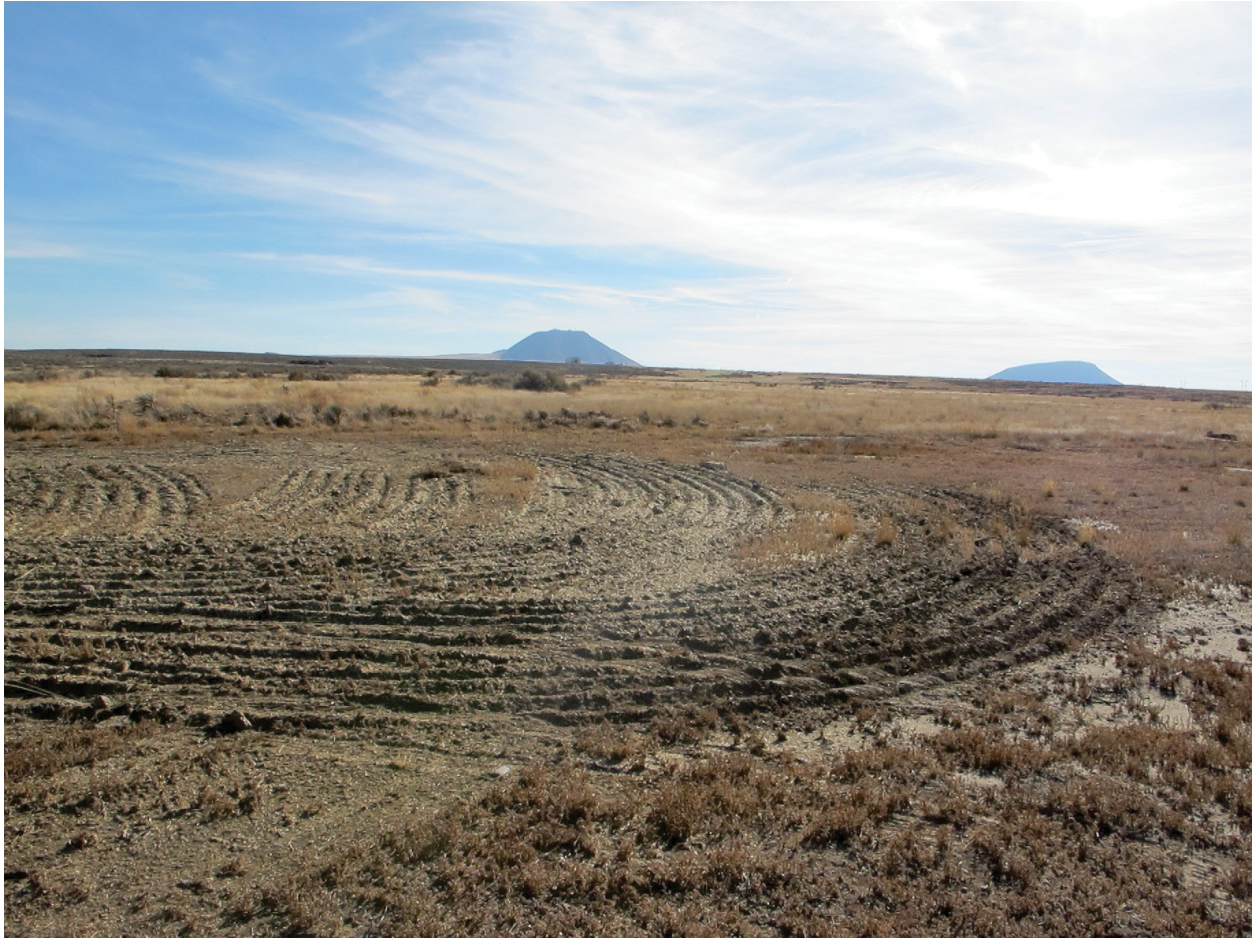
Bare soil is extensive at the location and kochia is the dominant species in the few locations that vegetation has become established. As shown in Figure 9, reseeding efforts did not cover the entire disturbed area, and supplemental water was not supplied to the seeded area. Furthermore, while the seed mixture used to revegetate the MFC Soil Pile location is unknown, there is no evidence the seeding was successful. The few plants establishing in the area besides kochia include non-natives such as halogeton, cheatgrass, and a few crested wheatgrass plants. It should be noted that even these species are sparse. The soil at this location has become crusted, and an adequate seedbed does not exist.

Figure 9. Figure of MFC Soil Pile Area showing where reseeding did not cover entire disturbed area.

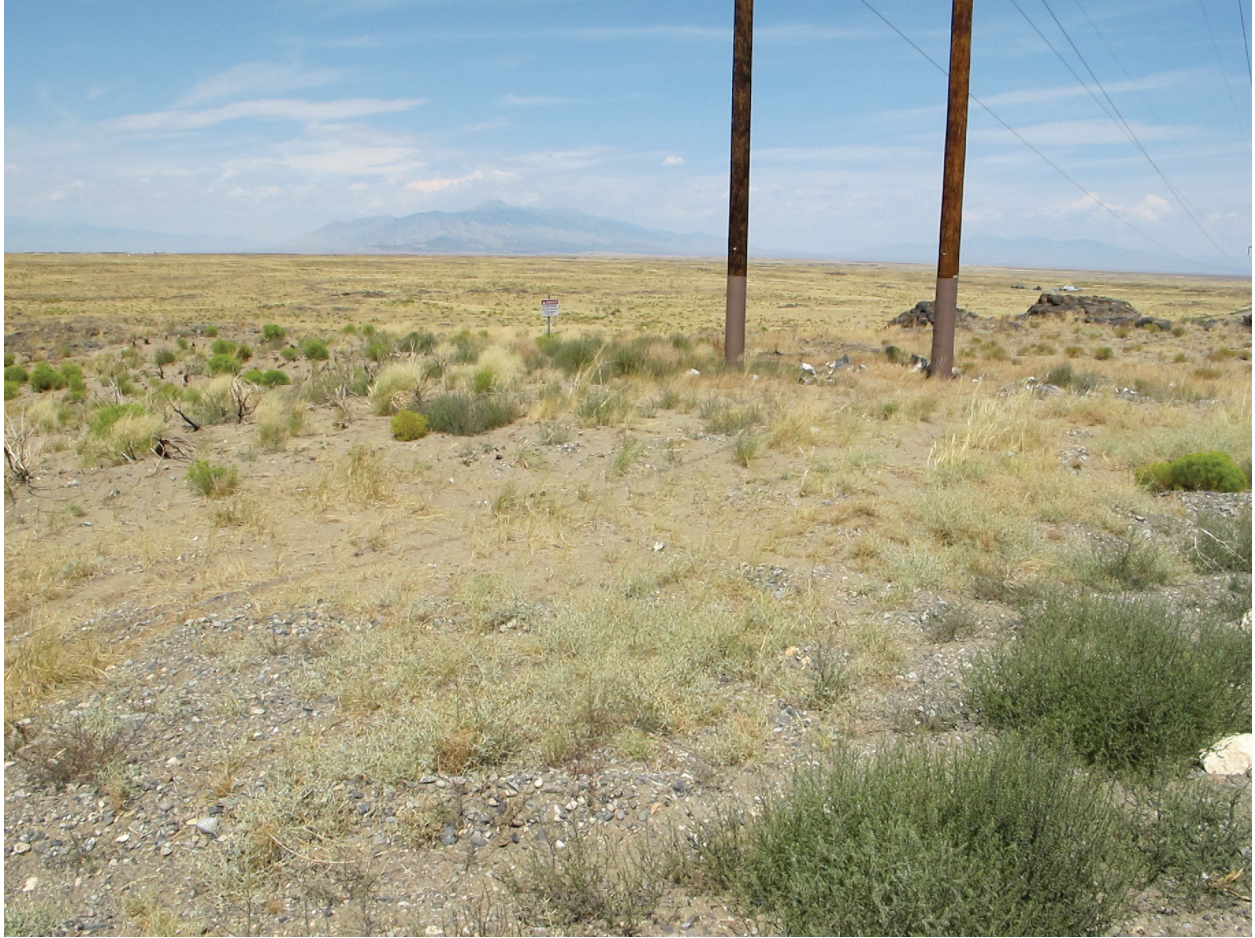
Figure 10. Power Pole 179 with heavy gravel and evidence of vehicle traffic.

It is recommended that if the disturbed area north of power pole 179 is needed to access the power lines then the area be graveled to provide that access, be monitored for noxious weed control by the

facility owner, and the area be removed from the Annual Revegetation Assessment. Otherwise, vehicle traffic should be prohibited on the revegetated area until revegetation has reached the 70% criteria for final stabilization.

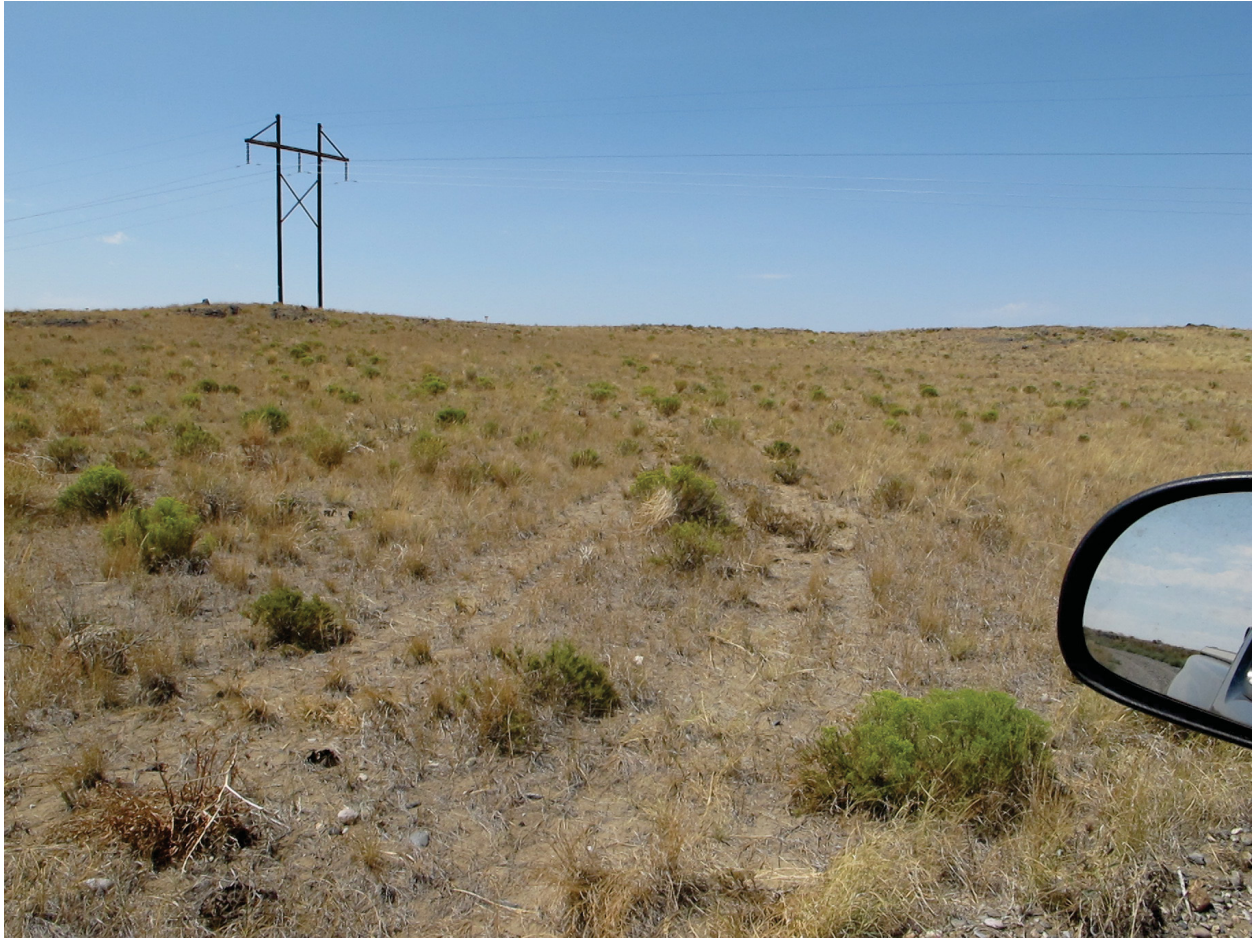
Figure 11. Off-road vehicle travel along the T-25 road.
